A Report on The Temporary Rehabilitation of the Sea-side Truss Bridge of Gunung Sitoli damaged by the M8.7 Nias Earthquake of 2005

(JSCE, Engineers Without Borders-Japan, EWoB-Japan)

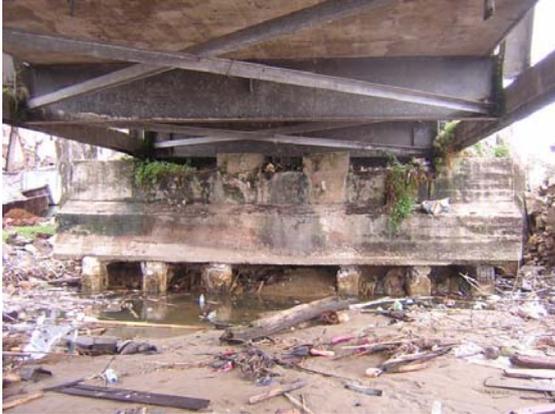
The wing-walls of the abutments of the bridge were ruptured and partly collapsed due to ground shaking as well as lateral spreading of ground. Furthermore, the fillings of abutments were settled by more than 250mm. There is no visible damage to the superstructure of the bridge. The piles of the NW abutment pier were ruptured. Furthermore, the steel reinforcing bars are corroded and the corrosion resulted in a considerable amount of area reduction of the bars (Figure 2a,c,d).

(a) NW abutment with visible piles

The piles heads are damaged and their steel bars have been corroded. If no pre-cautions are taken, the pier heads may further settle and cause some uneven settlements. It is recommended to cast a reinforced slab of concrete around the perimeter of the both abutments and to fill the gap between the ground and pier slab as illustrated in Figure 7.

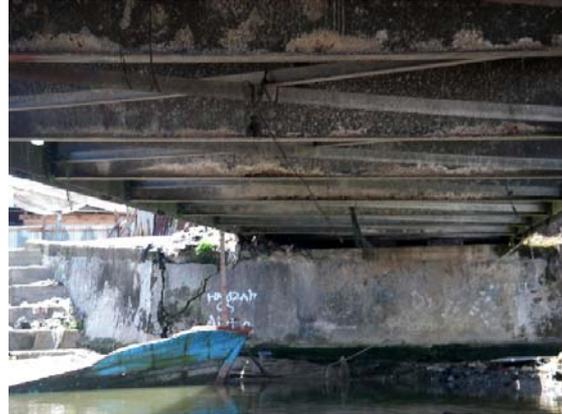
Although the piles of the SE abutment pier are not visible, the abutment pier was settled and moved towards the sea. The settlement of the SE abutment is not even and the settlement of the seaside of the pier is greater than that of the mountain side (Figure 2b,e) Because of uneven settlement, there is a gap between the shoe of the

(b) SE abutment

The motion of the bridge during the passage of vehicles may cause some damage to superstructure if much heavier vehicles are allowed to pass over the bridge. The main cause of this vibration is thought to be the gap between the shoe(upper bearing plate) of the superstructure and the seating(lower bearing plate) of the pier at the seaside of the SE abutment. Therefore, inserting a steel platen wedge (jacks would probably be needed), which fits the gap geometry seen in Figure 2e, must be used to eliminate the gap between the superstructure and pier.

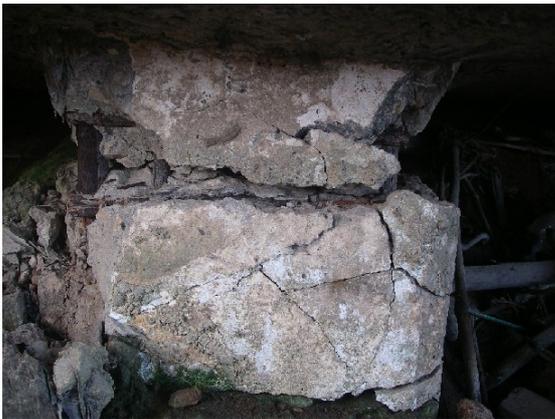
(c) Broken cast-in pile head (NW-Ab.)

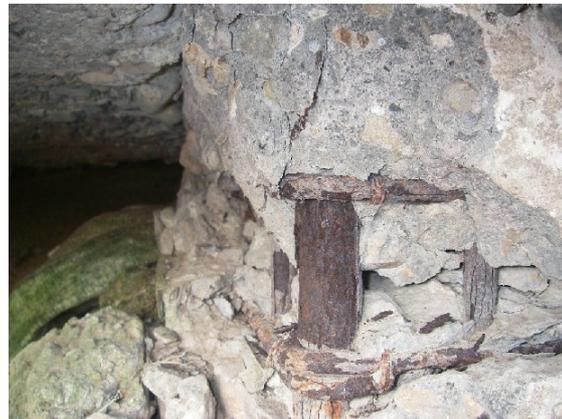
(d) Corroded steel bars of a pile (NW-Ab.)

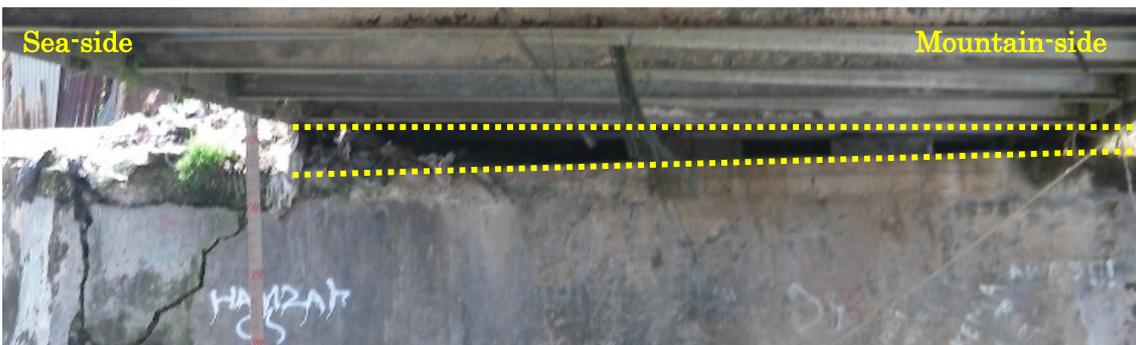
superstructure and the seating of the SE pier. When trucks pass over the bridge, the bridge shakes and the torsion vibration of the superstructure is induced.

(e) Uneven settlement of the SE abutment. The settlement at the seaside of the pier is greater than that at the mountainside

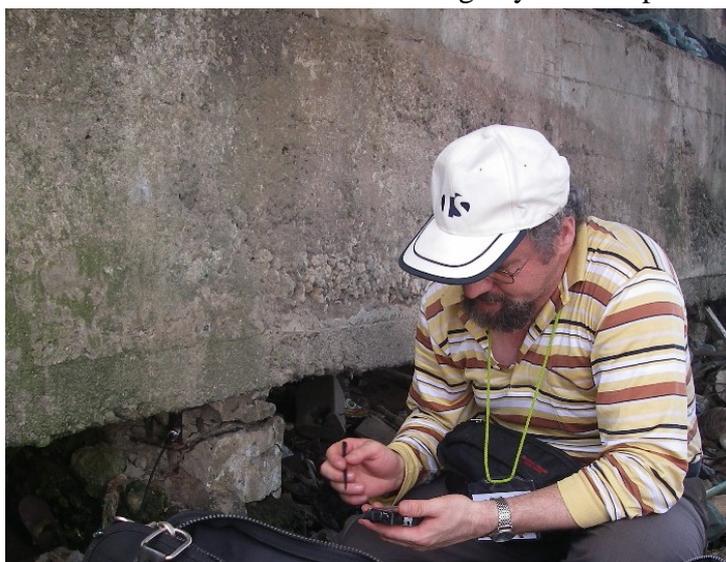
Figure 4. Measurement on the breakage and corrosion state of reinforcing bars

The authors made some measurements using a portable vibration measurement device produced by IMV Corporation and an accelerometer produced by SRIC. The vibration device can measure only one component and is able to store the both acceleration wave data and its FFT analysis. The accelerometer can measure three components of accelerations. Figure 3 shows some views of the measurements on the Truss bridge. In addition, some measurements were carried out on the corrosion state and possible breakage of reinforcing bars embedded in piles of the NW abutment (Figure 4).

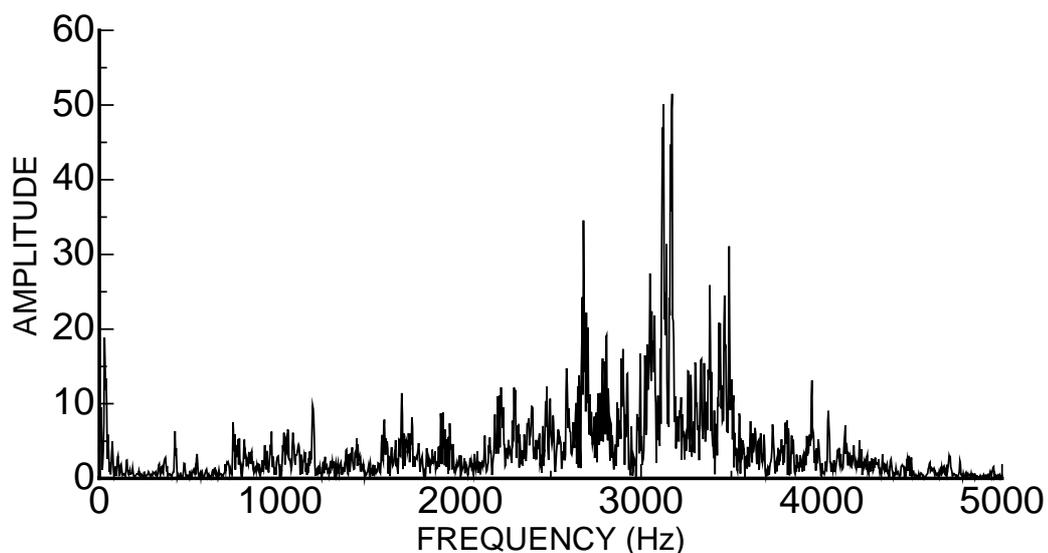
Figure 5. FFT spectra of vertical acceleration response of the bridge

Figure 5 shows FFT spectra of the vertical vibration of the bridge. As noted from the figure, the superstructure seems to be behaving elastically. Figure 6 shows the acceleration response of the bridge for vertical component during the passage of a 6-7 tonf truck. The axial and traverse components of the acceleration response of the bridge are small while the vertical component indicates a non-symmetric very high acceleration response, which implies a torsion type vibration of the superstructure of the bridge.
