# **A Report on The Temporary Rehabilitation of the Sea-side Truss Bridge of Gunung Sitoli damaged by the M8.7 Nias Earthquake of 2005**

(JSCE, Engineers Without Borders-Japan, EWoB-Japan)

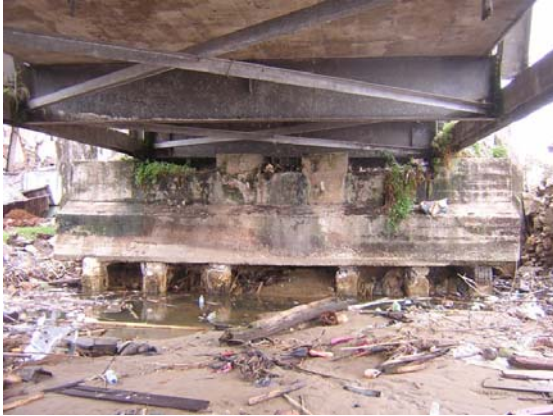
The wing-walls of the abutments of the bridge were ruptured and partly collapsed due to ground shaking as well as lateral spreading of ground. Furthermore, the fillings of abutments were settled by more than 250mm. There is no visible damage to the superstructure of the bridge. The piles of the NW abutment pier were ruptured. Furthermore, the steel reinforcing bars are corroded and the corrosion resulted in a considerable amount of area reduction of the bars (Figure 2a,c,d).

(a) NW abutment with visible piles

The piles heads are damaged and their steel bars have been corroded. If no pre-cautions are taken, the pier heads may further settle and cause some uneven settlements. It is recommended to cast a reinforced slab of concrete around the perimeter of the both abutments and to fill the gap between the ground and pier slab as illustrated in Figure 7.

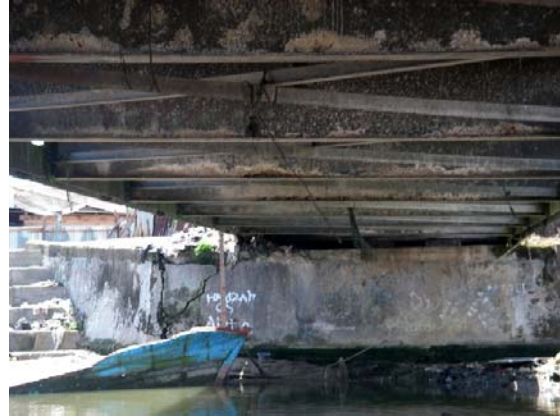
Although the piles of the SE abutment pier are not visible, the abutment pier was settled and moved towards the sea. The settlement of the SE abutment is not even and the settlement of the seaside of the pier is greater than that of the mountain side (Figure 2b,e) Because of uneven settlement, there is a gap between the shoe of the

superstructure and the seating of the SE pier. When trucks pass over the bridge, the bridge shakes and the torsion vibration of the superstructure is induced.

(b) SE abutment

The motion of the bridge during the passage of vehicles may cause some damage to superstructure if much heavier vehicles are allowed to pass over the bridge. The main cause of this vibration is thought to be the gap between the shoe(upper bearing plate) of the superstructure and the seating(lower bearing plate) of the pier at the seaside of the SE abutment. Therefore, inserting a steel platen wedge (jacks would probably be needed), which fits the gap geometry seen in Figure 2e, must be used to eliminate the gap between the superstructure and pier.

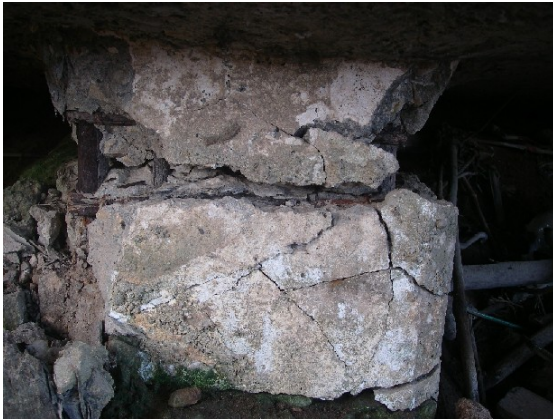
(c) Broken cast-in pile head (NW-Ab.)

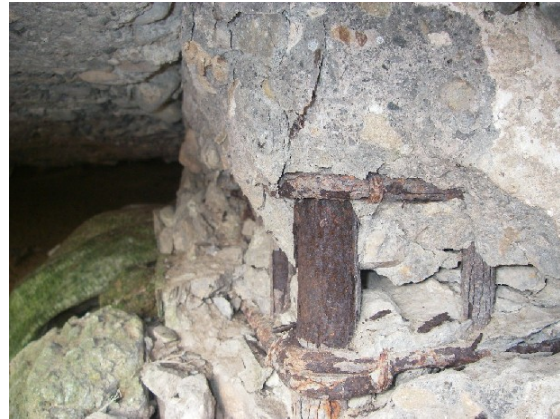
(d) Corroded steel bars of a pile (NW-Ab.)

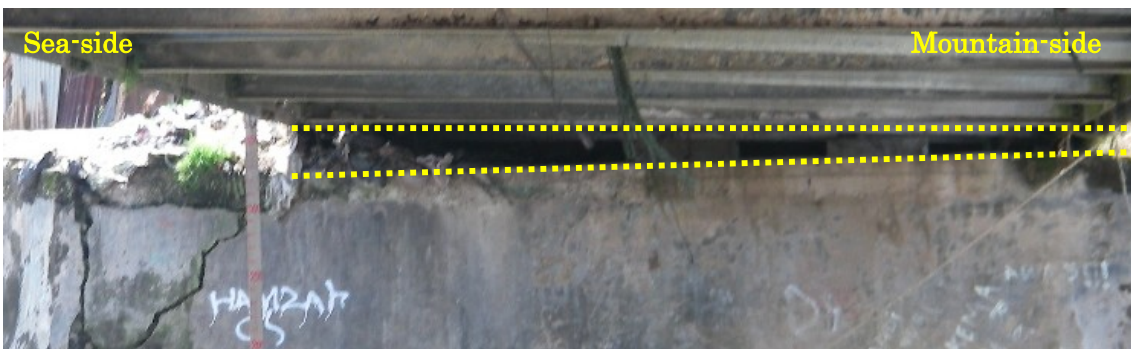
(e) Uneven settlement of the SE abutment. The settlement at the seaside of the pier is greater than that at the mountainside

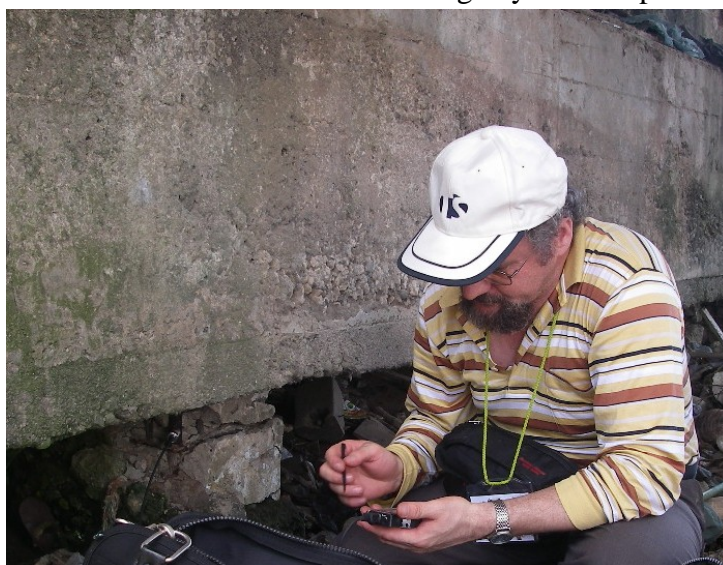
Figure 4. Measurement on the breakage and corrosion state of reinforcing bars

The authors made some measurements using a portable vibration measurement device produced by IMV Corporation and an accelerometer produced by SRIC. The vibration device can measure only one component and is able to store the both acceleration wave data and its FFT analysis. The accelerometer can measure three components of accelerations. Figure 3 shows some views of the measurements on the Truss bridge. In addition, some measurements were carried out on the corrosion state and possible breakage of reinforcing bars embedded in piles of the NW abutment (Figure 4).

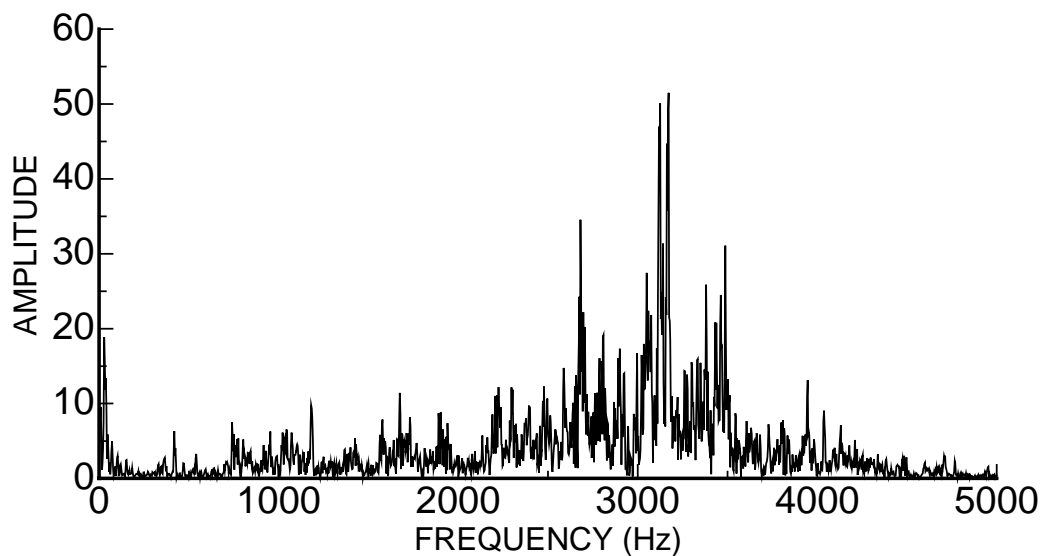
Figure 5. FFT spectra of vertical acceleration response of the bridge

Figure 5 shows FFT spectra of the vertical vibration of the bridge. As noted from the figure, the superstructure seems to be behaving elastically. Figure 6 shows the acceleration response of the bridge for vertical component during the passage of a 6-7 tonf truck. The axial and traverse components of the acceleration response of the bridge are small while the vertical component indicates a non-symmetric very high acceleration response, which implies a torsion type vibration of the superstructure of the bridge.
