A Report on The Temporary Rehabilitation of the Sea-side Truss Bridge of Gunung Sitoli damaged by the M8.7 Nias Earthquake of 2005

(JSCE, Engineers Without Borders-Japan, EWoB-Japan)

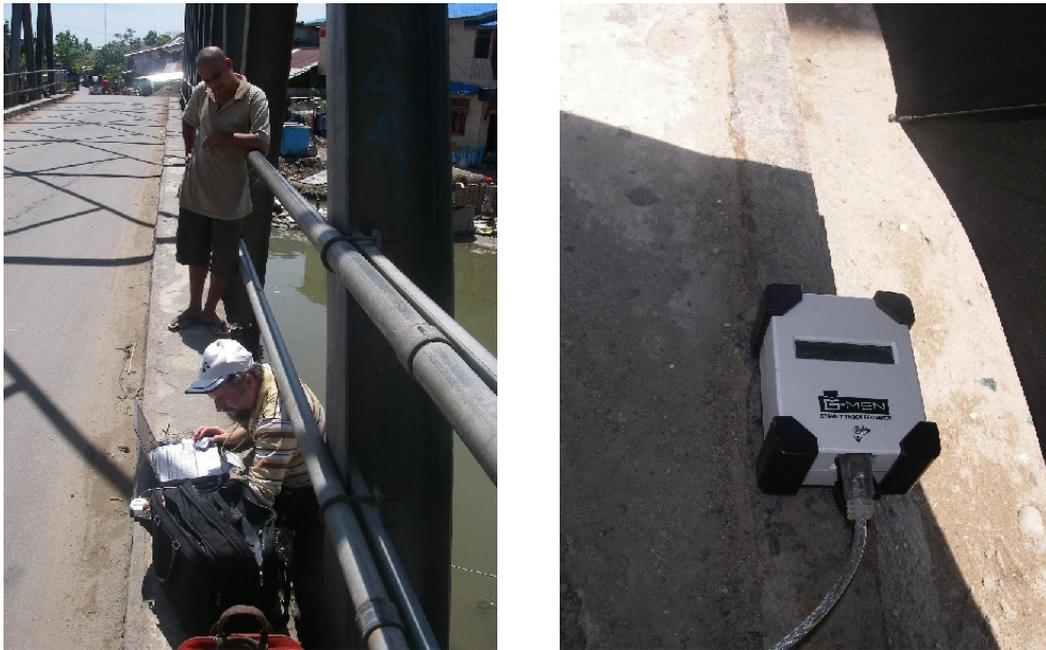
Figure 3. Acceleration measurements of the bridge by a 3-component accelerometer

Figure 5 shows FFT spectra of the vertical vibration of the bridge. As noted from the figure, the superstructure seems to be behaving elastically. Figure 6 shows the acceleration response of the bridge for vertical component during the passage of a 6-7 tonf truck. The axial and traverse components of the acceleration response of the bridge are small while the vertical component indicates a non-symmetric very high acceleration response, which implies a torsion type vibration of the superstructure of the bridge.

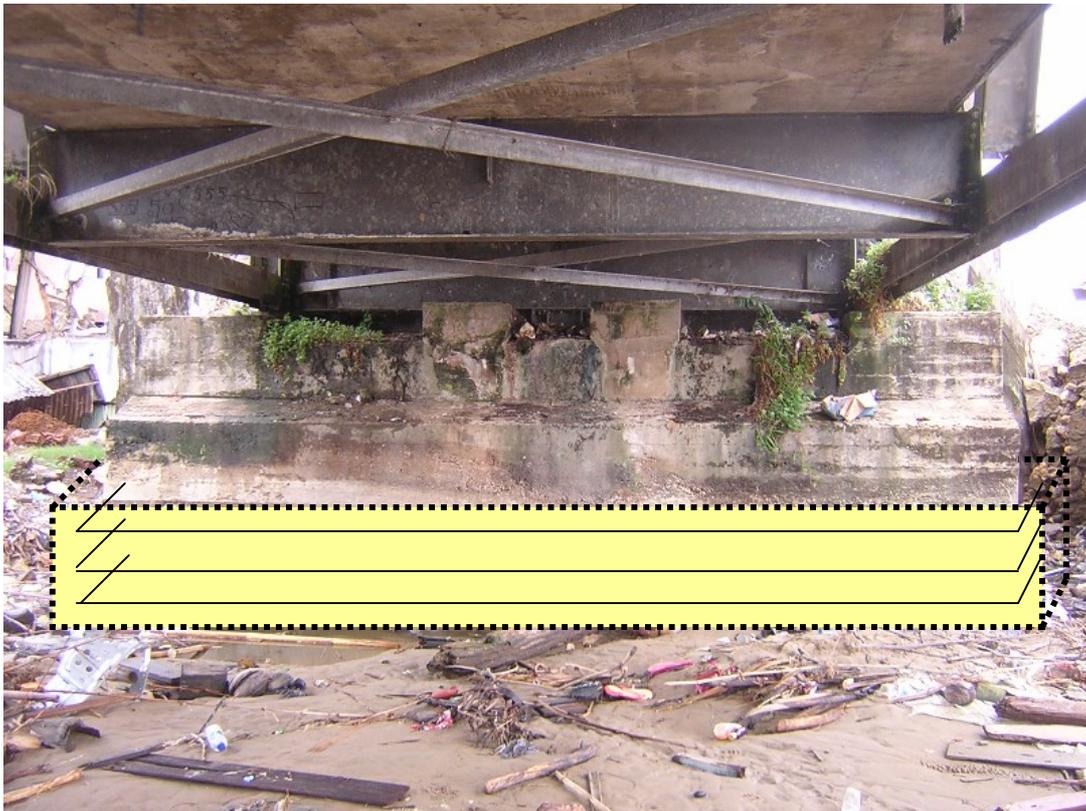
Figure 7. An illustration of casting a reinforced concrete slab around the pile heads of the piers of the abutments.

The piles heads are damaged and their steel bars have been corroded. If no pre-cautions are taken, the pier heads may further settle and cause some uneven settlements. It is recommended to cast a reinforced slab of concrete around the perimeter of the both abutments and to fill the gap between the ground and pier slab as illustrated in Figure 7.
