# **A Report on The Temporary Rehabilitation of the Sea-side Truss Bridge of Gunung Sitoli damaged by the M8.7 Nias Earthquake of 2005**

(JSCE, Engineers Without Borders-Japan, EWoB-Japan)

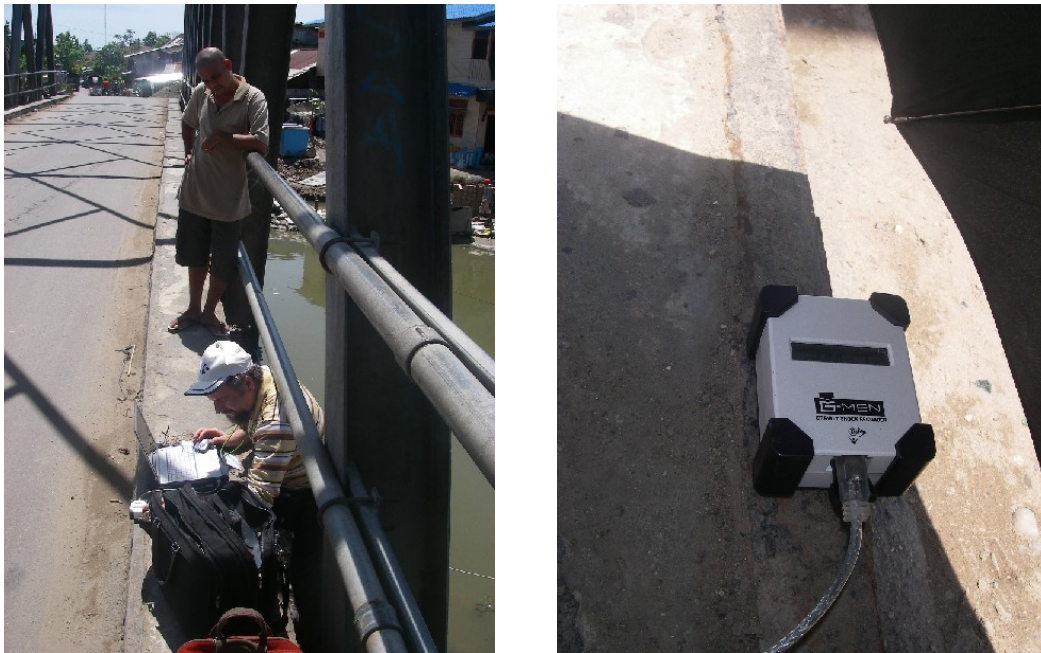
Figure 3. Acceleration measurements of the bridge by a 3-component accelerometer

The authors made some measurements using a portable vibration measurement device produced by IMV Corporation and an accelerometer produced by SRIC. The vibration device can measure only one component and is able to store the both acceleration wave data and its FFT analysis. The accelerometer can measure three components of accelerations. Figure 3 shows some views of the measurements on the Truss bridge. In addition, some measurements were carried out on the corrosion state and possible breakage of reinforcing bars embedded in piles of the NW abutment (Figure 4).
